CERTIFICATE OF LOCATION OF GOVERNMENT CORNER

NORTH QUARTER Corner of Section 4, Township 107 N, Range 40 W, 5th P.M.

STATE OF MINNESOTA, County of MURRAY

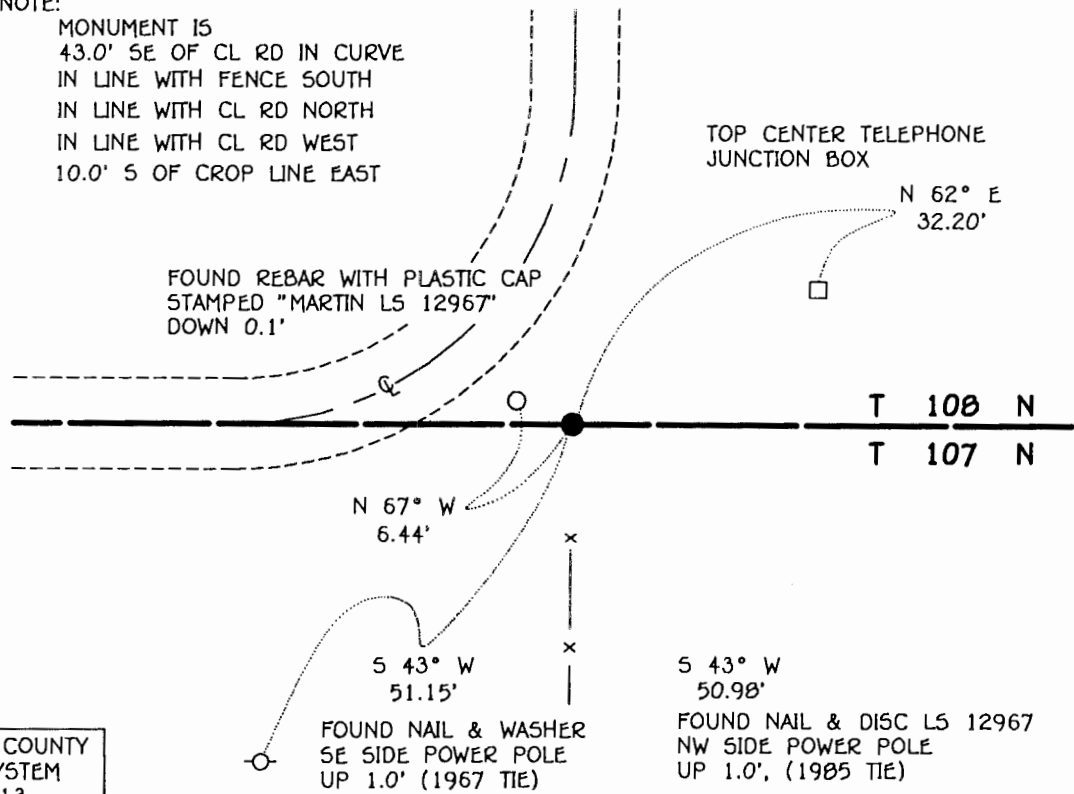
SKETCH OF REFERENCE TIES

- On 7-2-97 found a 1" DIAMETER IRON PIPE, DOWN 0.2'
DATE
- left monument as found, lowered monument, removed monument (explain)
- On 7-2-97 Placed a 3/4" x 12" REBAR WITH ALUMINUM CAP STAMPED
DATE "DNR SURVEY MARKER" IN CENTER OF IRON PIPE

NOTE:
 MONUMENT IS
 43.0' SE OF CL RD IN CURVE
 IN LINE WITH FENCE SOUTH
 IN LINE WITH CL RD NORTH
 IN LINE WITH CL RD WEST
 10.0' S OF CROP LINE EAST

Analysis of the above information led the DNR Bureau of Engineering to conclude that the found iron pipe which was set in 1967 on line between adjoining section corners and in line with the center line of a road north marks the obliterated location of the corner. Do not accept the found rebar as the location of corner because it was established from an incorrect location for the northeast corner of Section 5. Searched for and found record ties as shown on sketch of reference ties.
