CERTIFICATE OF LOCATION OF GOVERNMENT CORNER

NORTH QUARTER Corner of Section 18, Township 106 N., Range 42 W., 5th P.M.

STATE OF MINNESOTA, County of MURRAY

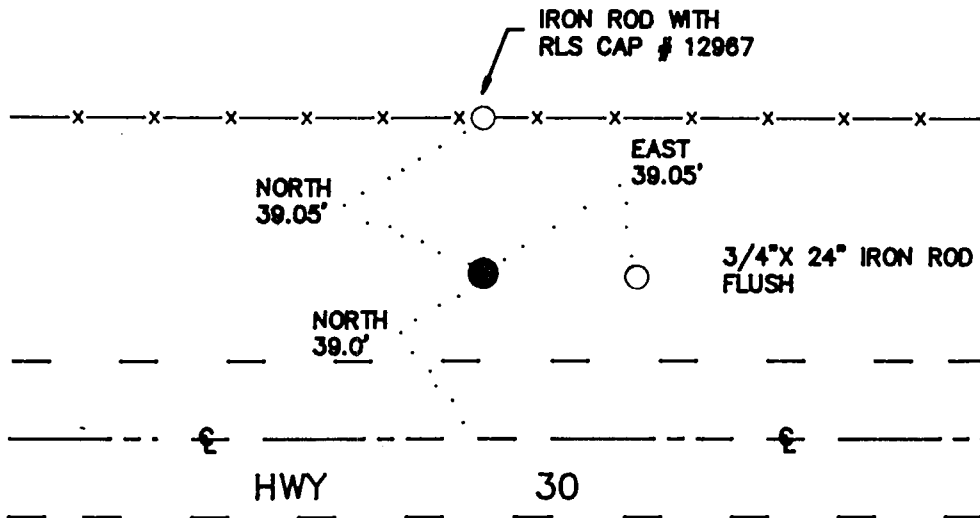
SKETCH OF REFERENCE TIES

On 6/27/89 found a IRON ROD, FLUSH WITH RLS #12967 ON CAP
DATE

- 1989 The DNR Bureau of Engineering conducted a search for this corner and found a 1/2" iron rod with plastic cap stamped "RLS #12967" flush in ditch bottom. Iron rod measures:

39.0 ft. north of the center line of Highway 30
1319.70 ft. from the southeast corner W $\frac{1}{2}$ SE $\frac{1}{4}$
2627.96 ft. from the center of Section 7

Analysis of the available information led the DNR Bureau of Engineering to conclude that the found iron rod marks the location of the corner.
