CERTIFICATE OF LOCATION OF GOVERNMENT CORNER

NORTH QUARTER Corner of Section 33, Township 108 N, Range 40 W, 5th P.M.

STATE OF MINNESOTA, County of MURRAY

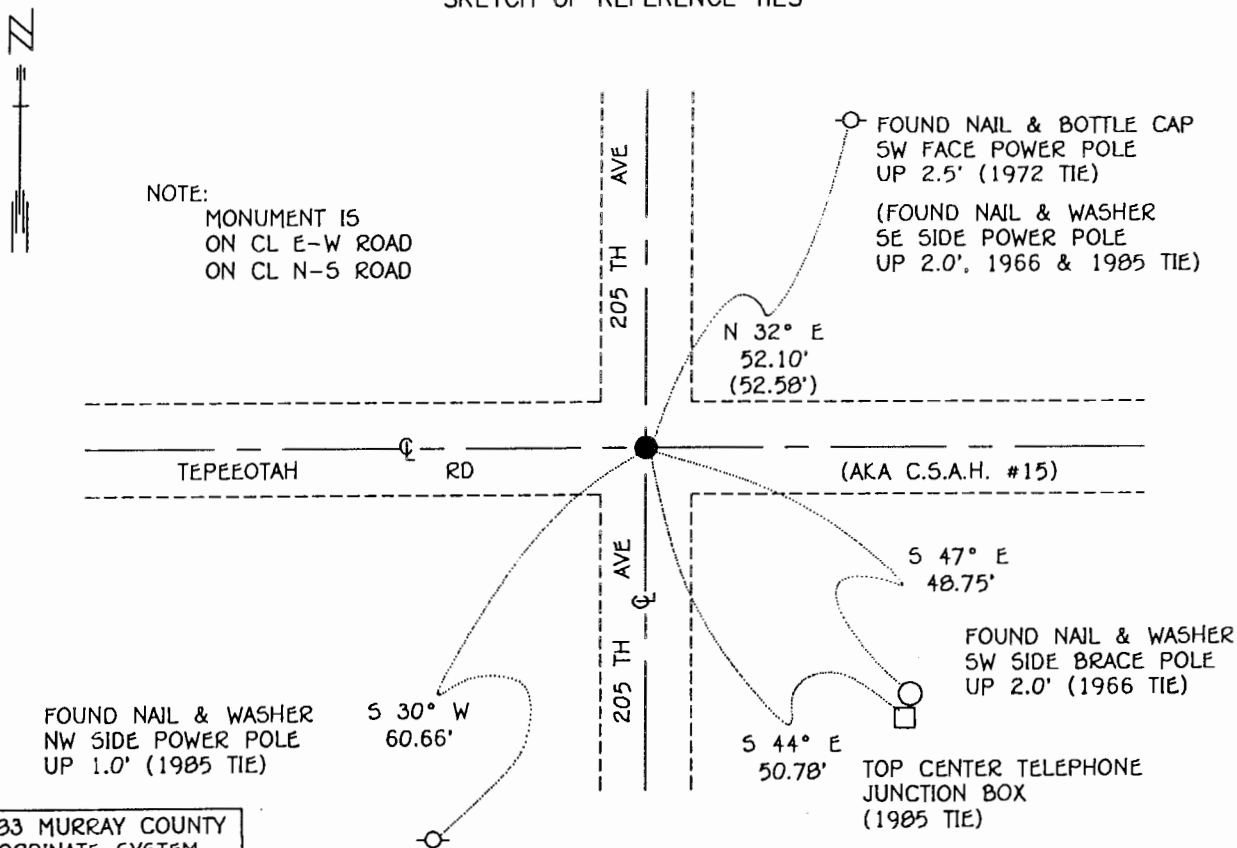
SKETCH OF REFERENCE TIES

■ On 6-30-97 found a CONCRETE MONUMENT, DOWN 1.1', OVER POINTED STONE,
DATE DOWN 2.4'

NOTE:
 MONUMENT IS
 ON CL E-W ROAD
 ON CL N-S ROAD

1997 June 30, DNR Bureau of Engineering found a ½ inch diameter by 11 inch long rebar down 0.3 of a foot over a conic shaped concrete monument (7" top, 11" bottom, 10" high) down 1.1 feet over a pointed top stone down 2.4 feet at corner. Searched for and found record ties as shown on sketch of reference ties. The monuments were found to be:

■ On 6-30-97 Placed a 3/4" x 12" REBAR WITH ALUMINUM CAP STAMPED
DATE "DNR SURVEY MARKER", DOWN 0.1', OVER CONCRETE MONUMENT

Analysis of the above information led the DNR Bureau of Engineering to conclude that the found rebar, concrete monument and stone mark the location of the corner. Discarded the rebar and set a DNR Survey Marker in its place.
