CERTIFICATE OF LOCATION OF GOVERNMENT CORNER

NORTH QUARTER Corner of Section 20, Township 107N, Range 39W

5th Principal Meridian, State of Minnesota, County of MURRAY

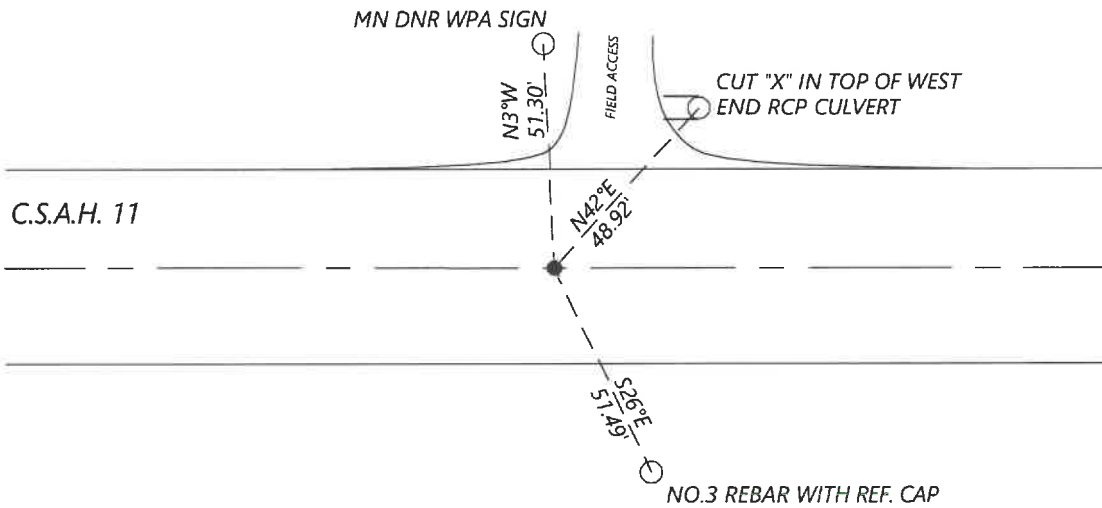
SKETCH OF REFERENCE TIES

At the corner location shown on the sketch:

On 8/27/2020 found a 3/4" OPEN PIPE WITHOUT CAP, 0.6' BELOW GRADE
DATE

N.T.S.

- Sept. 2020 *Westwood Professional Services searched and found a $\frac{3}{4}$ " iron pipe at the corner. Coordinates fit well with the 2012 Highway Dept. records. Review of the 2000 and 2015 surveys suggests the corner location may be 1-1.5ft to the west. I accepted the location of the found monument and established reference ties.*
