CERTIFICATE OF LOCATION OF GOVERNMENT CORNER

NORTHEAST Corner of Section 16, Township 105 N, Range 41 W, 5th P.M.

STATE OF MINNESOTA, County of MURRAY

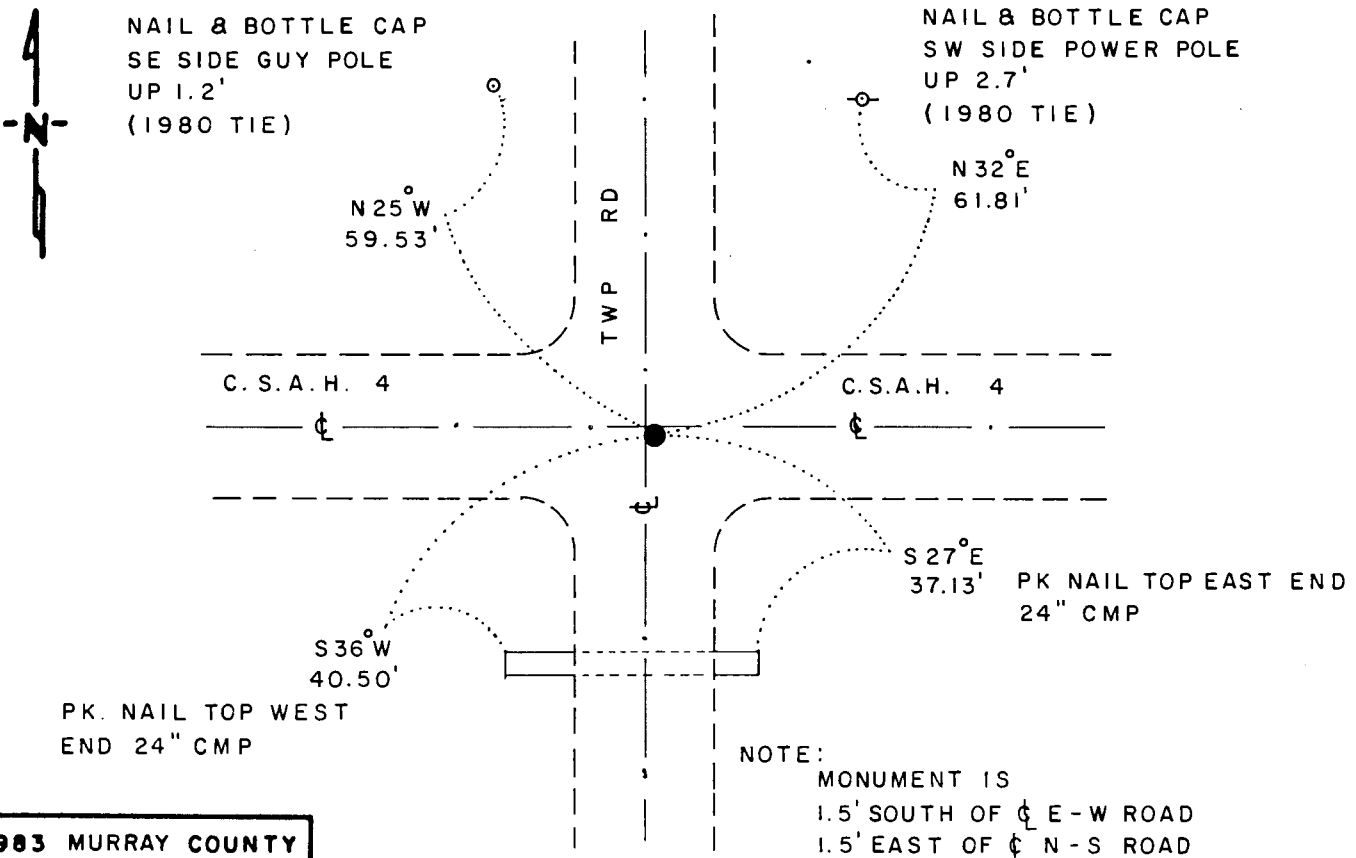
SKETCH OF REFERENCE TIES

At the corner location shown on the sketch

NOTE:
MONUMENT IS
1.5' SOUTH OF E-W ROAD
1.5' EAST OF N-S ROAD

BEARINGS OBSERVED WITH COMPASS

- 1990 March, DNR Bureau of Engineering found a 5/8 inch diameter by 24 inch long rebar with a plastic cap stamped RLS #12967 at corner. Removed the rebar and probed beneath it to a depth of 4 feet in search of a stone but found nothing. Discarded the found rebar and set a DNR Survey Marker in its place. Searched for and found record ties as shown on sketch of reference ties. The rebar was found to be:
